Can-Am™ Commander™

Cleaning Procedure of Exhaust Area

This is an addendum to the Operator's Guide of Can-Am Commander model year 2011, 2012 and 2013 vehicles.
It should be kept with the Operator's Guide in the vehicle.

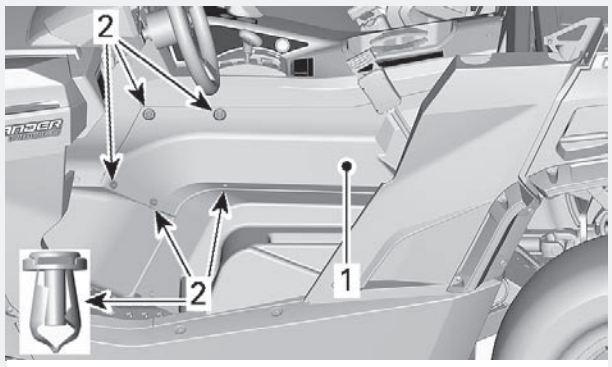
FRONT PORTION OF THE LH LATERAL CONSOLE PANEL
1. LH lateral console panel
2. Plastic rivets

2.1 Remove plastic rivets securing the lateral console panel and keep for reinstallation later on.
To know more about how to remove the plastic rivets, please see next page.

2.2 Remove the lateral console panel.

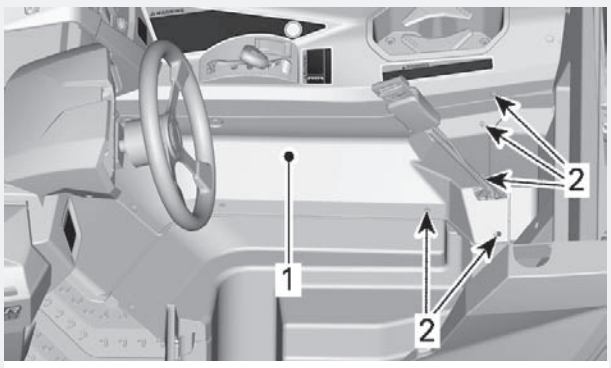
REAR PORTION OF THE LH LATERAL CONSOLE PANEL
1. LH lateral console panel
2. Plastic rivets

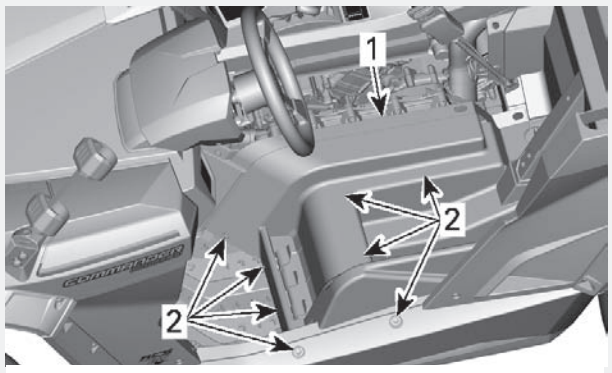
1. Under seat storage compartment
2. Plastic rivets

3.1 Remove plastic rivets securing the under seat storage compartment and keep for reinstallation later on.

3.2 Remove under seat storage compartment. This part will still be attached to the vehicle by the seat belt.

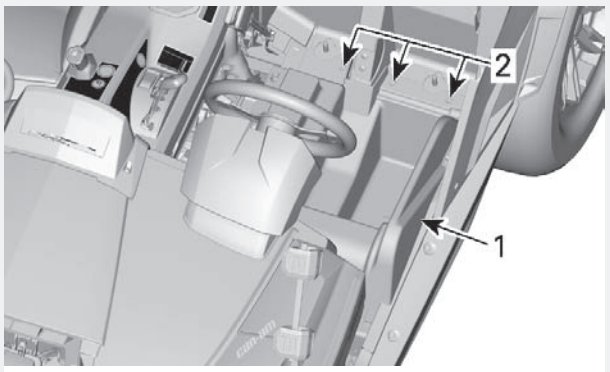
1. Under seat storage compartment
2. Plastic rivets

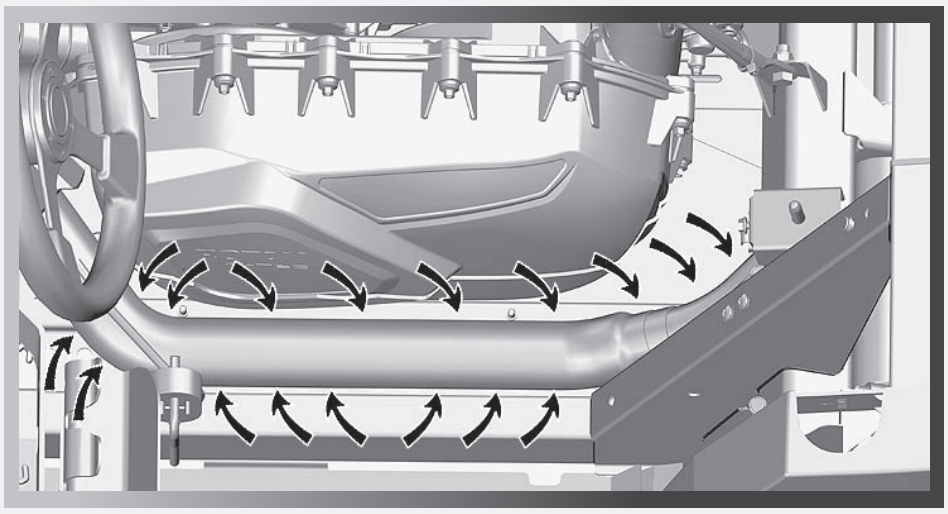
Step 4

Access to area that may require cleaning

4.1 Wearing gloves, hand remove all excess debris around exhaust.

4.2 Using a garden hose, thoroughly clean the area so no more debris can be in contact with exhaust.

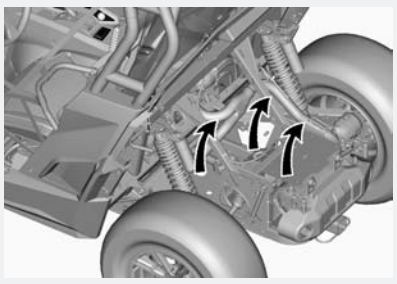
Step 6

Under cargo box cleaning

6.1 Tilt the cargo box and clean the area surrounding the exhaust.

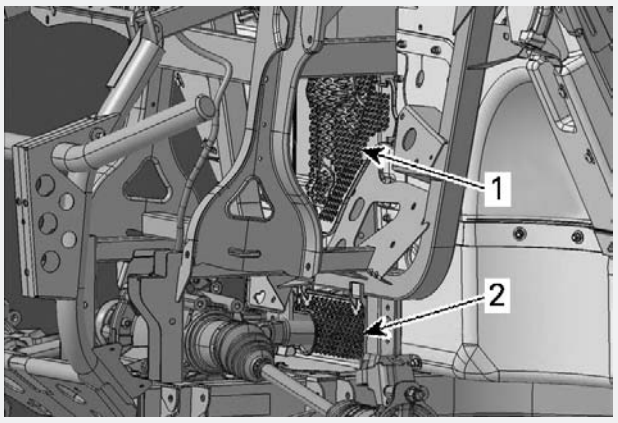
Step 7

For vehicles equipped with the Front Grill Kit

Can-Am Commander - Accumulation of debris in the exhaust area in very specific riding terrains and conditions.

7.1 Make sure that the two grills are clean.

7.2 Make sure that the two grills are still attached properly.

7.3 Make sure that the two grills are in good condition.
